Asphalt surfacing on timber bridges

Florian Scharmacher¹, Andreas Müller², Maurice Brunner³

Summary

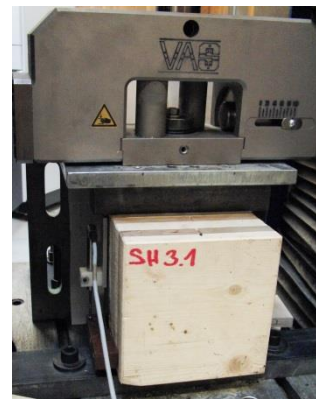
Figure 5: Detail of the test machine readied for a shear test

The selected material combinations and layer compositions were subjected to shear and tensile bonding (adhesion) tests. Figure 4 and Figure 5 show the set-up for the shear tests.

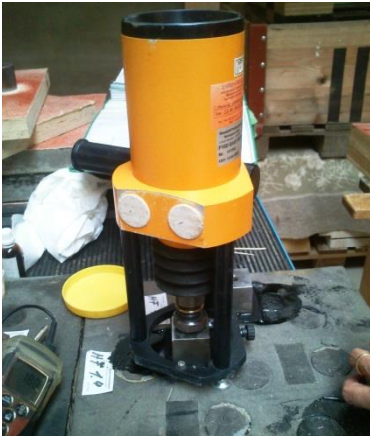
Figure 7: Mobile adhesion tensile testing machine of the company BTS Baucontrol

A layer of cyanoacrylate adhesive was used to attach the test specimen onto the indenter of the testing machine. The testing area of the surfacing was cut free from the surrounding surfacing area, so that only this area was subjected to the pulling force (Figure 7, Figure 8). The tests were carried out in the laboratories of the Bern University of Applied Sciences in Biel by the company BTS Baucontrol. The tests were force-regulated at a rate of 300 N/s.

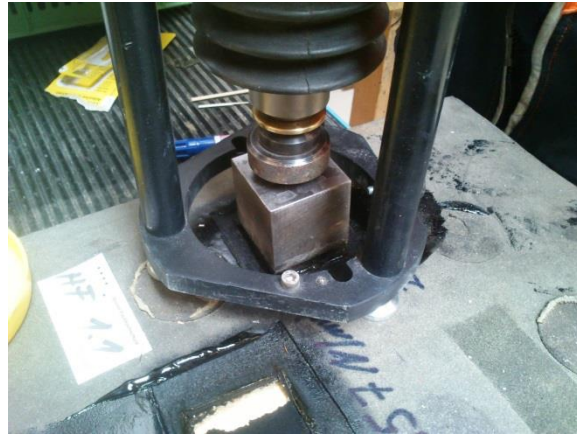
Figure 8: The indenter is pulling at the barely visible PBM sealant underneath it

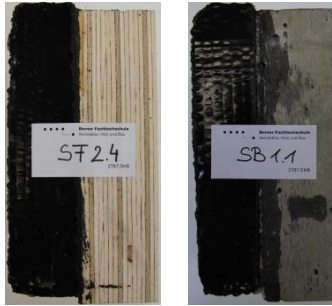
Figure 10: Plastic deformation of a test specimen with PBM sealant on CLT (left) and on concrete (right)

The test results showed different load-bearing behaviours for the two sealants used. Layer compositions with polymer bitumen membranes (PBM) exhibited very ductile behaviour: the yield shear stress of 0.2 - 0.6 N/mm² was attained at an elastic deformation of 1 - 2 mm. The plastic deformation after the yielding was considerable: the tests were stopped after a deformation of 10 mm was attained (Figure 10). After the tests, the elastic deformation of the specimens was slowly but fully recovered after a few days.

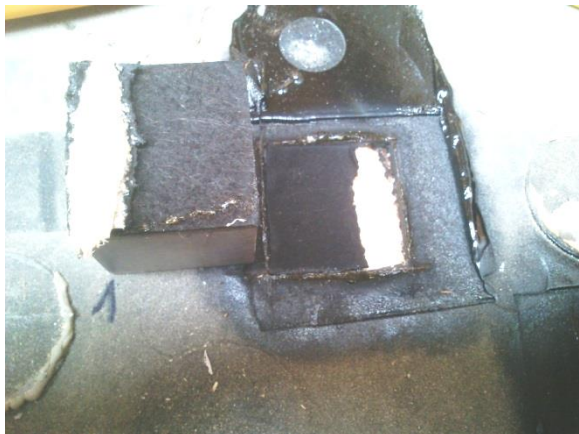
Figure 16: Test specimen with PBM sealant after successful adhesion tensile test [5]

All test specimens fulfilled the adhesion tensile strength requirements according to the standard SN 640450a:2009. Figure 16 and Figure 17 show two test specimens after the adhesion tensile tests. The evalua-

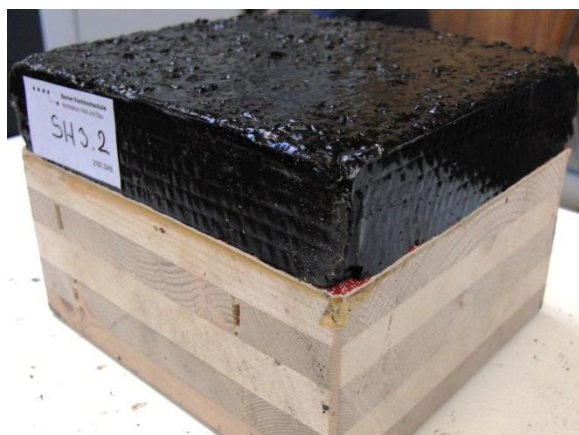
Figure 20: No blistering observed in this specimen of asphalt surfacing on CLT

During the manufacture of the test specimens for the shear tests, in particular during the pouring of the hot asphalt onto the bridge deck, some remarkable observations of blistering were made. Many of the specimens with an epoxide primer suffered some clear blistering. The epoxide primer is known to be open to water vapour diffusion. The heat of the asphalt apparently caused water vapour to rise from the timber to accumulate directly at the bottom face of the sealant. The water vapour caused a partial separation of the sealant from the timber deck: in some places it penetrated the sealant and collected as “blisters” in the asphalt (Figure 20, Figure 21, Figure 22).

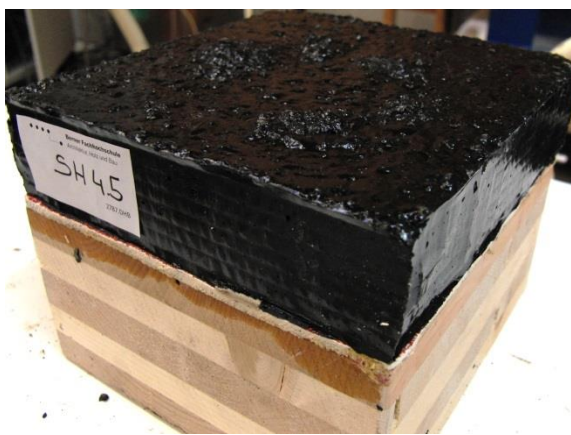
Figure 21: Clear blistering in the surfacing of this specimen of asphalt surfacing on CLT

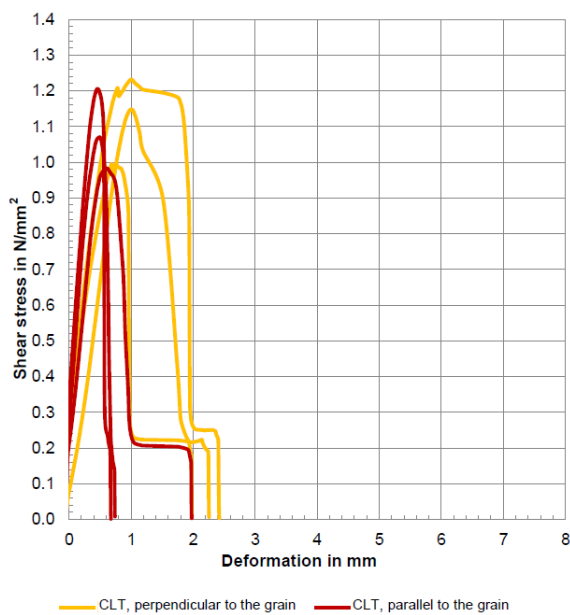
Figure 23: Shear stress / deformation diagram of a test specimen without blistering

The effect of the blistering which occurred in some specimens was evident during the later shear tests. The shear strength of samples with blisters was reduced by approximately 10 - 15% as compared to an undisturbed sample. The obvious reason was the reduced contact area for the shear force. It was also observed that the test specimens which exhibited blistering were more ductile in their load-bearing behaviour than the specimens which did not suffer blistering. A plausible explanation might be that the weakened material around the blisters were deformed more readily but then got caught in the indentations on the wood surface (Figure 23, Figure 24).

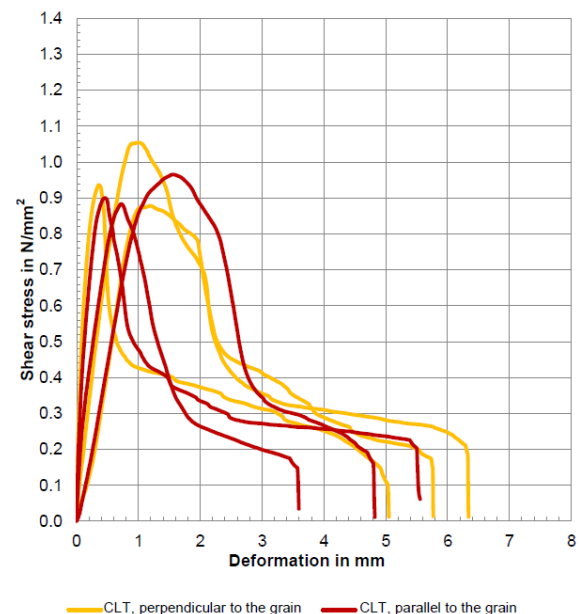
Figure 24: Shear stress / deformation diagrams of test specimens with blistering

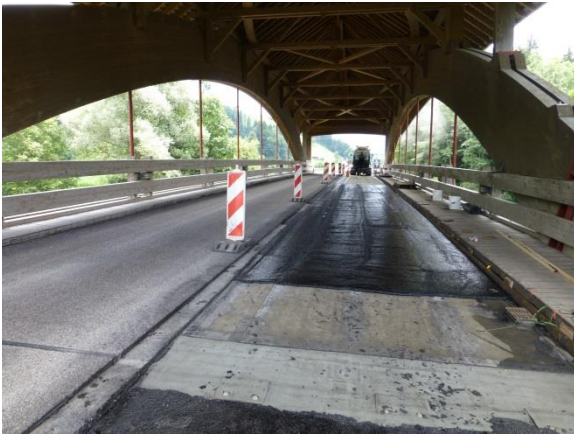
Figure 25: Picture of the Bubenei Bridge during the asphalt coating

The research team was allowed to scientifically observe the renovation of the surfacing of the Bubenei Bridge (Canton of Berne, Switzerland). The massive timber deck was surfaced with a 25 mm thick asphalt structure [4] supplied with vent holes but without a shear connection (Figure 25). Despite the high wood moisture content, no increased blistering was observed. The temperature in the wooden deck was observed to rise very slowly during the application of the temperature-modified asphalt: a sudden evaporation of water could not occur according to the temperature measurements (Figure 26).

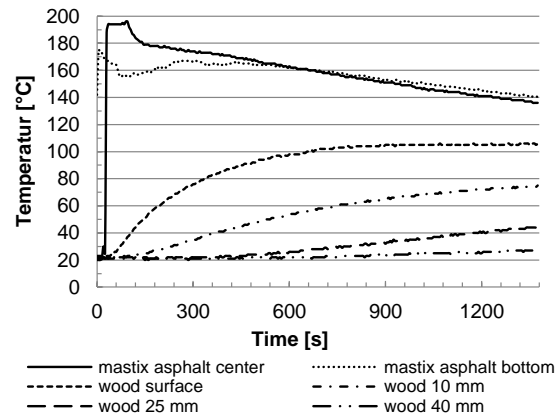
Figure 26: Temperature profile for a timber deck during asphalt coating
