Assessment of timber structures using the X-Ray technology

Keywords: Timber, Connections, Nondestructive testing, Assessment, X-Ray

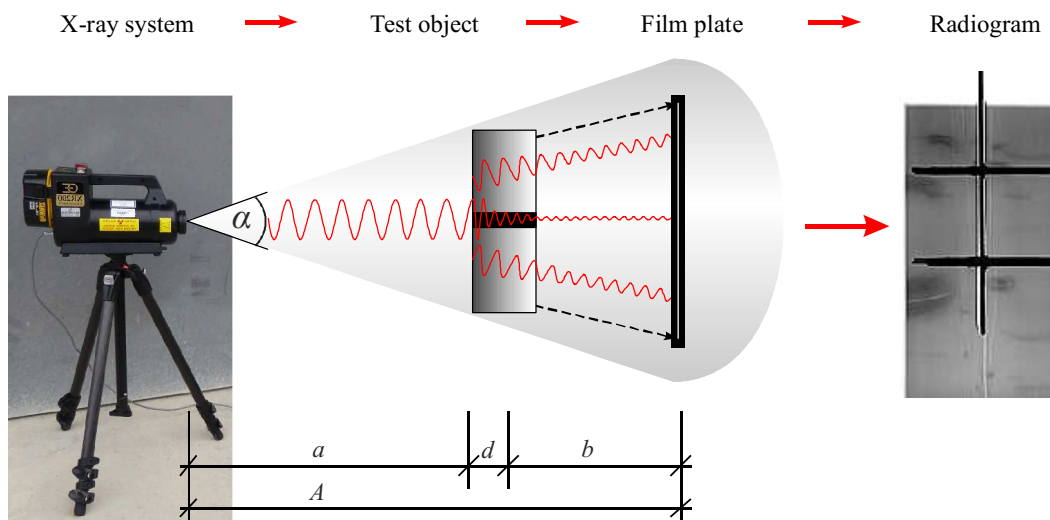
Fig. 1 Principle process of X-ray technology and investigations

transmitter and the film plate. The X-rays transmitted travel through the test object and will be absorbed with different intensities before they hit the film plate. The material specific absorption of the X-rays leads to the so called radiogram which will finally be transferred in a grayscale picture. The volume of the three dimensional test object will be reproduced as a two dimensional picture.

The X-ray radiography depends on the impulse intensity of the X-rays, the distance of the test object to the transmitter as well as to the film plate and also the thickness of the material. The principle of the process is shown in Fig. 1, where the test object is located between the X-ray

Furthermore the distance a between the transmitter and the test object and the distance b between the test object and the film plate, see Fig. 1 was verified related to the accuracy and sharpness of the radiograms. The same test object with the steel screw inserted in a wood block with a thickness of 70 mm was used. The increase of the distance b results in a smaller projected area where the object is enlarged compared to the original size, as shown in Fig. 4. On the other hand, the reduction of distance a leads to a clear “burned” spot and unusable radiograms. A minimum distance a of about 1 meter was necessary for the test configuration with a film plate of 30 by 40 cm. The relation between the two distances a and b is summarized in Fig. 5.

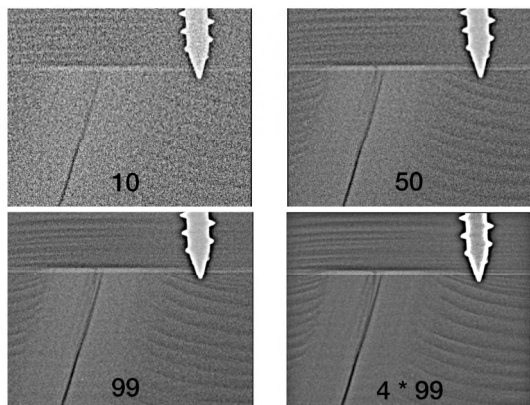
Fig. 2 Radiograms with different number of impulses

According to Eq. (1), the intensity I on the film plate increases linear with the intensity of the transmitter I_0 . The gray value of one pixel behaves proportional to the intensity and will increase. Fig. 2 shows the radiograms taken with different numbers of impulses from a steel screw tip inserted in wood block as test object. The test object had a constant thickness d of 70 mm. Increasing the thickness increases the absorption of the X-rays, so that for radiograms with comparable quality, the number of impulses has to be increased as well. The effect of the number of impulses was analyzed for two different thicknesses and is shown in Fig. 3.

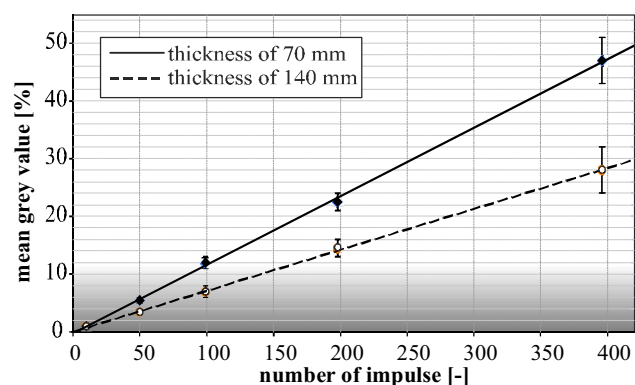
Fig. 3 Effect of number of impulse, the shadowed area marks the not useful configurations

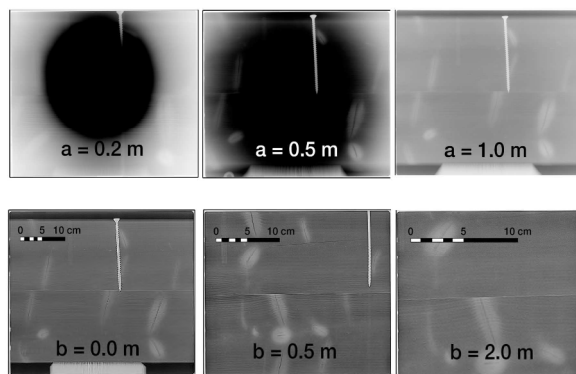
Fig. 4 Radiograms with different distances, top row distance a and bottom row distance b

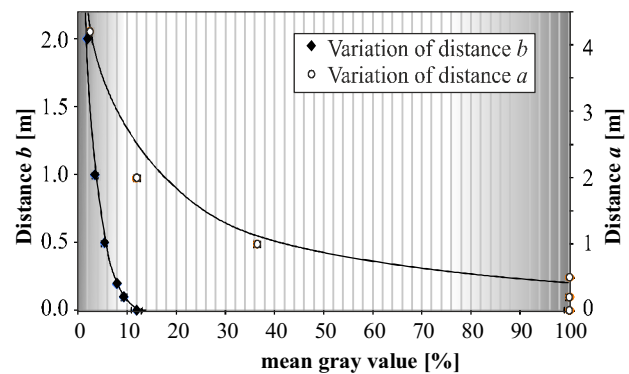
Fig. 5 Effect of distances of impulse, the shadowed area marks the not useful configurations

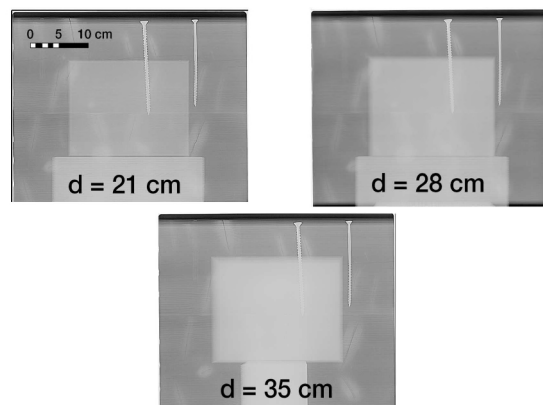
Fig. 6 Radiograms with different thicknesses of the test object

Finally the thickness of the test object was verified from 70 mm up to 350 mm. Hereby constant parameters for the number of impulse, distances of the test object to transmitter and film plate were used. The radiograms of the test object with the metal screw inserted in the wood block with different thicknesses are shown in Fig. 6. The contrast of the radiogram reduces with the increase of the thickness of the test specimen. The typical structural elements of wood on macro scale level are visible for thicknesses up to 200 mm. For greater thicknesses, only major differences are visible in the radiogram like parts of steel or wood. As summary, the relation between the mean gray value and the thickness is shown in Fig. 7.

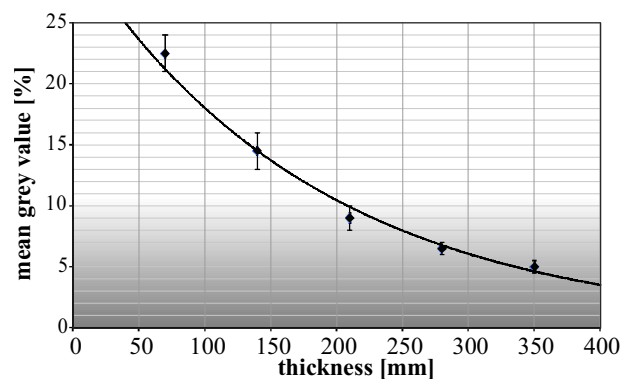
Fig. 7 Effect of thickness, the shadowed area marks the not useful configurations

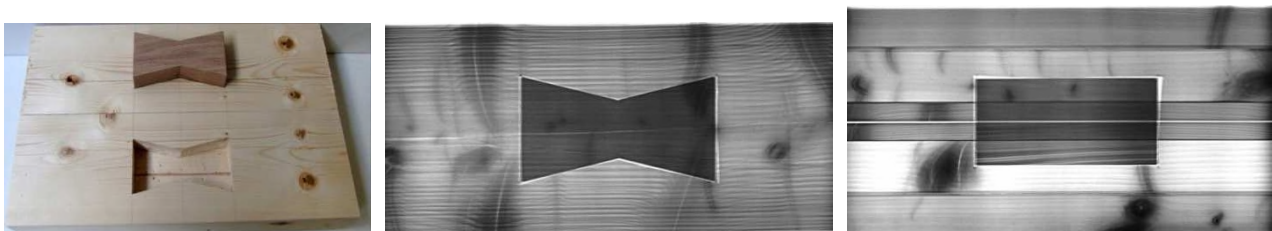
Fig. 8 Wood to wood connection with hardwood dowel

Assessment of wood and connections. The first investigations are done in the laboratory with samples of historical wood to wood connections or with mechanical connections. Fig. 8 shows a wood to wood connection with an internal hardwood dowel. Not only the two wood species, European spruce and beech, can be clearly distinguished but also differences within one material like knots and even the annual grow rings are visible. Furthermore the fitting accuracy of such a connection can be checked. In this case gaps are clearly detectable. As a practical application, a historical timber construction in a chateau was investigated. Wooden nails could be detected during the assessment of a multi layered beam construction, as shown in Fig. 9.

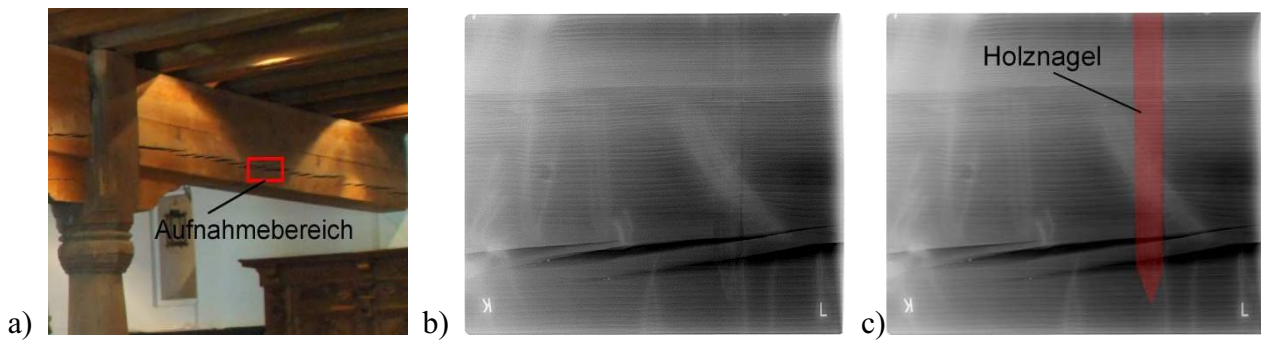
Fig. 9 Historical wood nail in multi layered wooden member, a) position of X-ray shot, b) original radiogram, c) wooden nail marked in radiogram

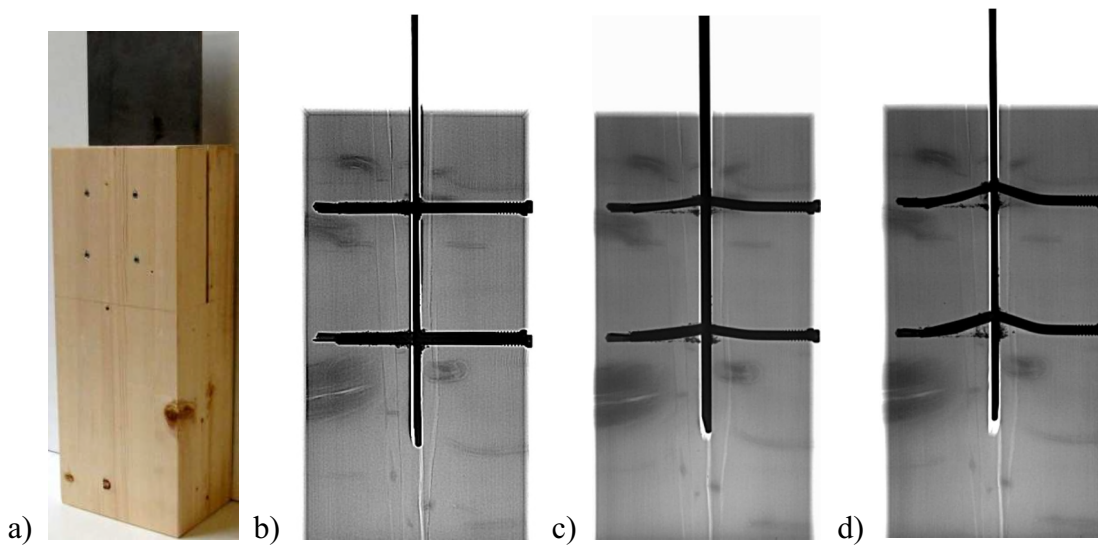
Fig. 10 Connection with mechanical fasteners, a) Test specimen, b) unloaded connection, c) and d) connection with plastic deformations

The assessment of timber connections with mechanical fasteners is shown in Fig. 10 for a dowelled connection with inner steel plate. The test specimen shown was loaded/unloaded in certain steps at the laboratory and X-rayed after each load step. For every case, the visual inspection of the outside area (heads of the fasteners) do not indicate any irregularities. But the radiograms show that inside the connection plastic deformations according to the Johansen theory, [15] already occurred, as shown in Fig. 10c)-d). The plastic deformations of the fasteners indicate an overloading and a failure of the connection. The connections have to be repaired in this case.

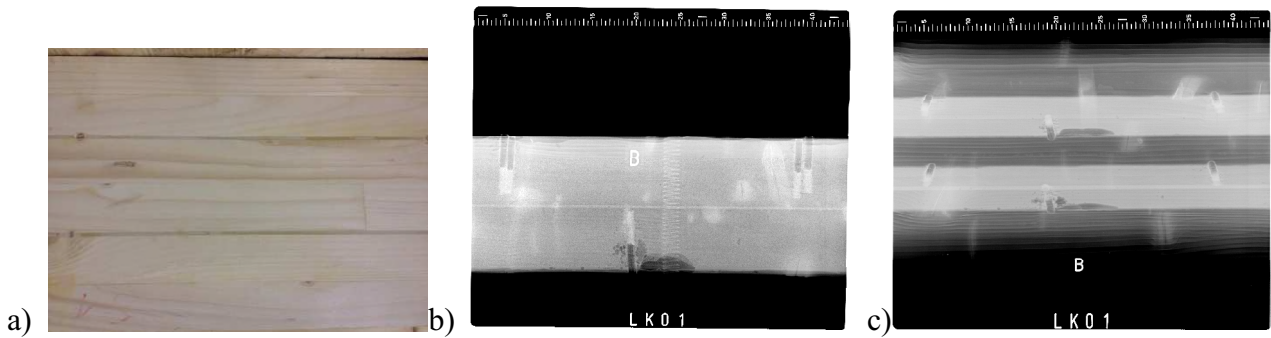
Fig. 11 Glulam member with two restructured cracks, a) test specimen, b) X-ray direction perpendicular to the glue-line (top view), c) X-ray direction inclined to glue-line

Assessment of restored glue lines and fungal/insect decay. Glulam is a common used engineered wood product for large span timber constructions. The assessment of these structures is a permanent task in order to ensure the integrity and performance. In some cases, the glue lines or cracks have to be restructured or supports and high stressed areas have to be reinforced. The assessment of restructured glue lines was therefore investigated with the mobile X-ray system within a research project. A glulam member with two restructured cracks was X-rayed in different directions to check the restoration. In the first radiogram, taken in a direction perpendicular to the glue-line planes and shown in Fig. 11b), a clear failure at the outside of the beam can be seen. But the allocation to one of the glue-lines or even the evaluation if there are more failures in the same direction is not possible. Fig. 11c) shows the final radiogram inclined to the glue-line plane. Here, the two restructured glue-lines can be separated from each other and the failure spots and injection holes are clearly visible for each glue-line. In this case, both glue-lines show the failure at the same position. Furthermore, the assessment of this member also shows voids and bubbles along the glue-line plane as well as in the injection holes. Depending of the size of these defects, the structural capacity of the beam and the strength of the restructured glue-line can be influenced. In a practical application, also voids and bubbles within a glued-in rod connection could be detected.

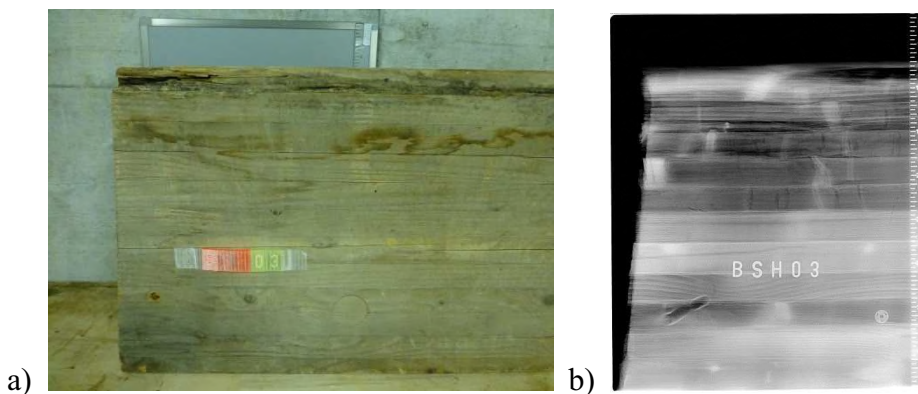
Fig. 12 Fungal decay in X-ray, a) test specimen, b) radiogram

In general fungal or insect decay can be observed within the visual inspection. But in some cases structural elements are covered or only viewable from one side, so that the mobile X-ray system can be used for detailed analyses or specification of assumptions. Fig. 12 shows as example of a glulam member with fungal decay in the top layers. The typical cubic failure structure is visible in the radiogram observed and allows estimating the dimension of the decay.
